Casualties

Tugboat hits barge and sinks at NY bridge construction site, killing 3

Three men were killed when their tugboat crashed into a construction barge and sank on the Hudson River.

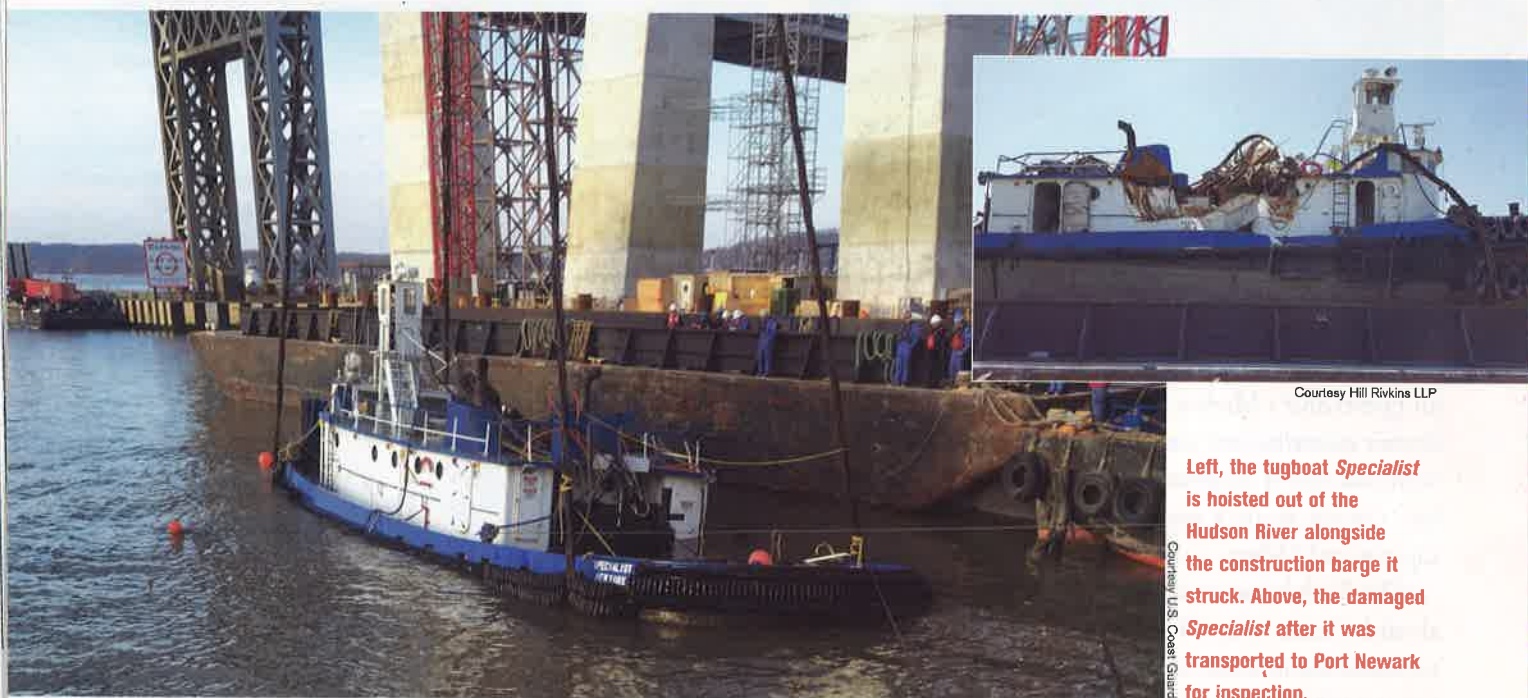
Left, the tugboat *Specialist* is hoisted out of the Hudson River alongside the construction barge it struck. Above, the damaged *Specialist* after it was transported to Port Newark for inspection.

The force of the impact drove the 62-year-old *Specialist* under the sloping bow of the stationary barge,

snapping the lines holding it to 533. The tug took on water and listed, and video shows that its wheelhouse was ripped off by the contact with the barge. Leathers said it sank 40 feet to the river bottom in about seven minutes. The crews on the other tugs tried to help *Specialist's* crew but were unable to reach them.

After the salvage, *Specialist* was taken to Port Newark.

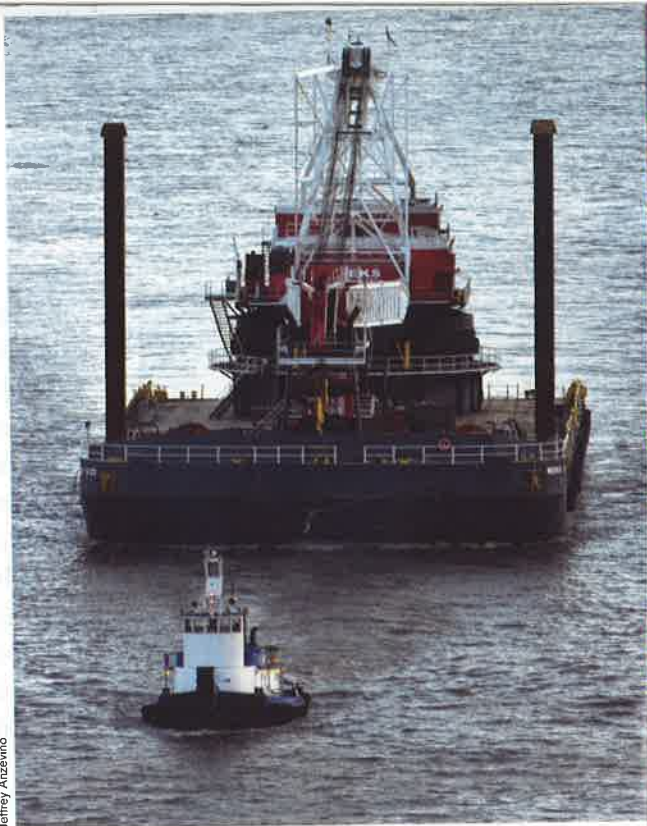
Specialist, by itself, tows the crane barge 533 up the Hudson River near Poughkeepsie, N.Y., on March 9. The fatal accident happened four days later while *Specialist* escorted the barge downriver with two other tugs.
